STATE OF CALIFORNIA
DEPARTMENT OF WATER RESOURCES
OROVILLE EMERGENCY RECOVERY – SPILLWAYS
TECHNICAL MEMORANDUM

Date: November 2, 2017

SUBJECT: Investigation and Initial Evaluation
Cracking of Erosion Resistant Concrete Invert Panels in the FCO
Spillway

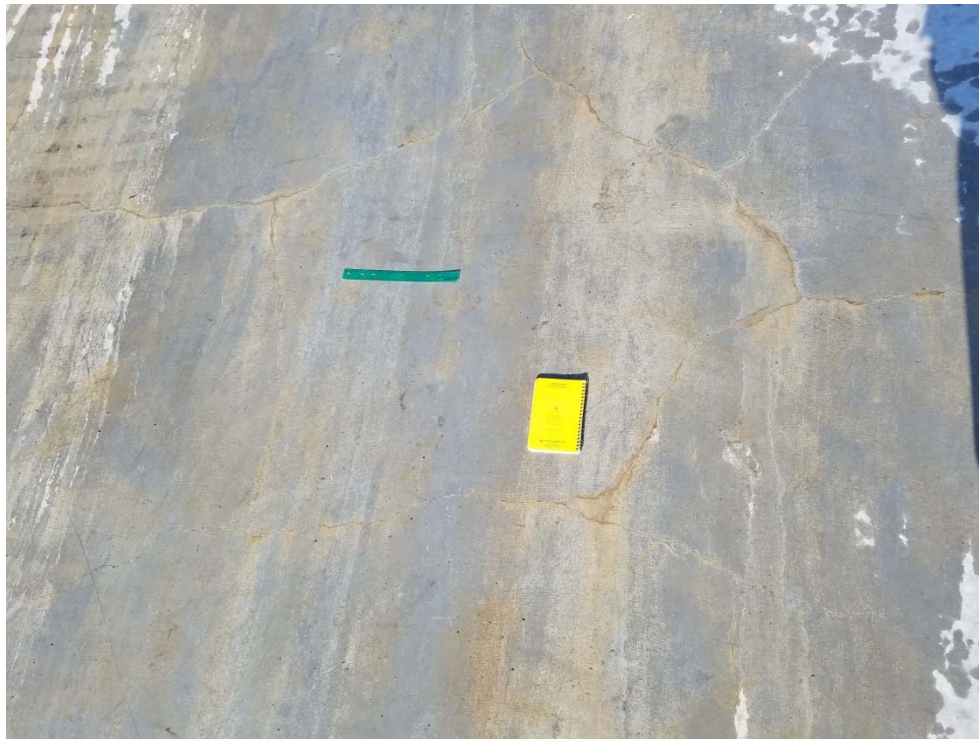
The cracking observed with the ERC invert panels in the FCO Spillway chute to date appear to be the result of early age cracking, which is caused by thermal deformation (due to cement hydration) and/or shrinkage deformation (autogenous shrinkage and plastic shrinkage). Early age cracking is summarized within the following pages or can be found in detail within ACI 231R-10. Figures 1-4 consist of photos of the typical cracking observed on site.

Figure 1: Typical Cracking Observed

It appears the majority of cracking visible is autogenous cracking, due primarily to the concrete being restrained by both underlying leveling concrete and anchors extending into the panel. After reviewing the mapping of cracks overlaid on the anchors, it is apparent that cracking is primarily between anchors supporting this theory.

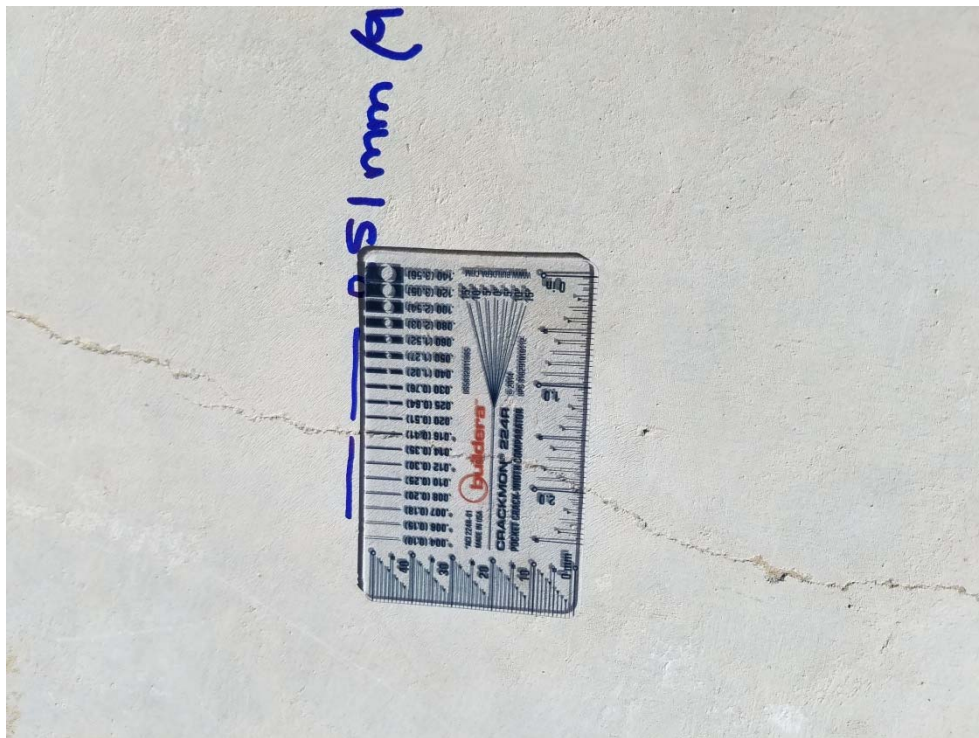
Figure 2: Typical Crack with Spalling and Raveling

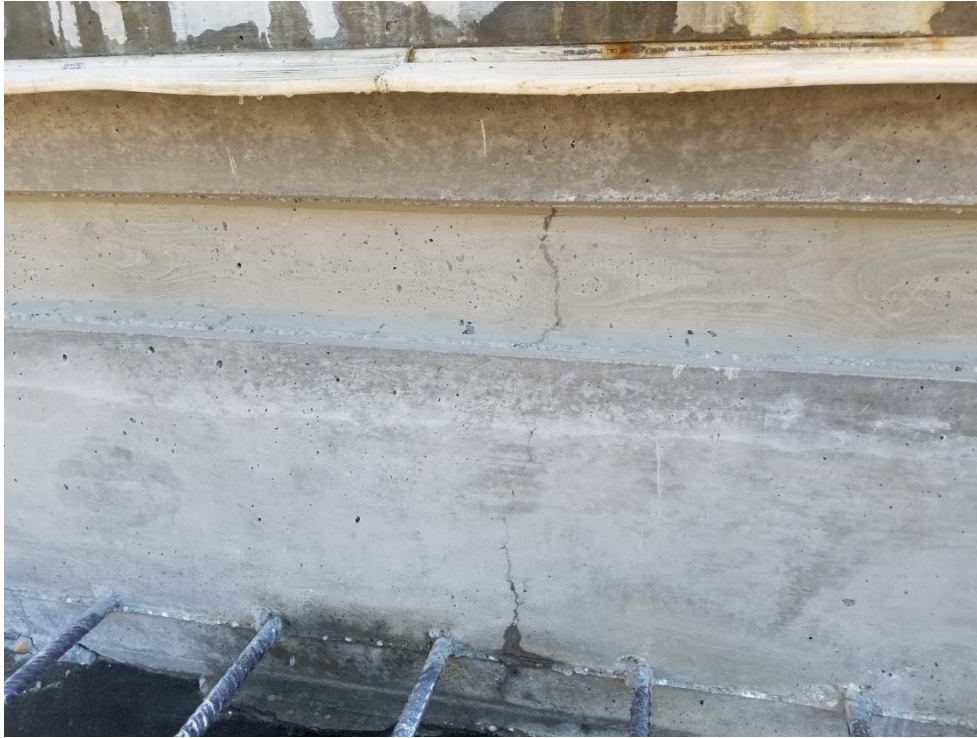
Figure 3: Typical Through Cracking Observed

As can be seen in Attachment 1, cracking observed in the spillway was random with average panel ERC crack widths ranging from less than 0.01 to 0.3 mm and an average width of 0.18 mm. The average crack frequency on the panel surface was found to be 80 ft. Most of the edge cracking appears to arrest at the top mat of reinforcement with some progressing through the entire panel. Table 2 shows a breakdown of the ratings of the thirty-four panels mapped to date.

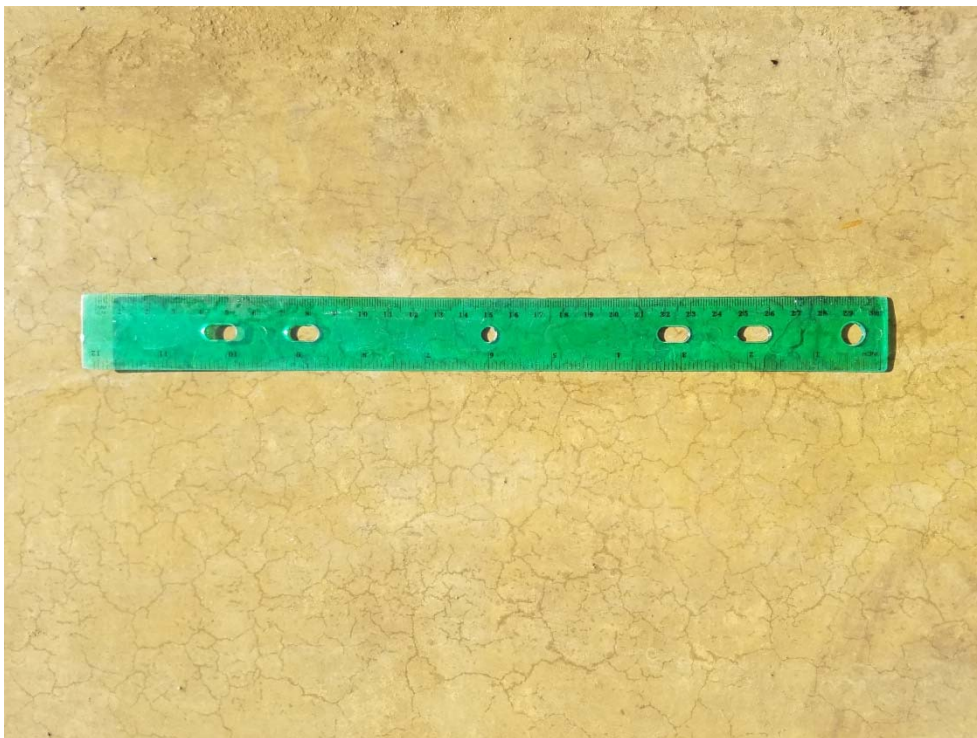
Figure 4: Typical Cracking Observed

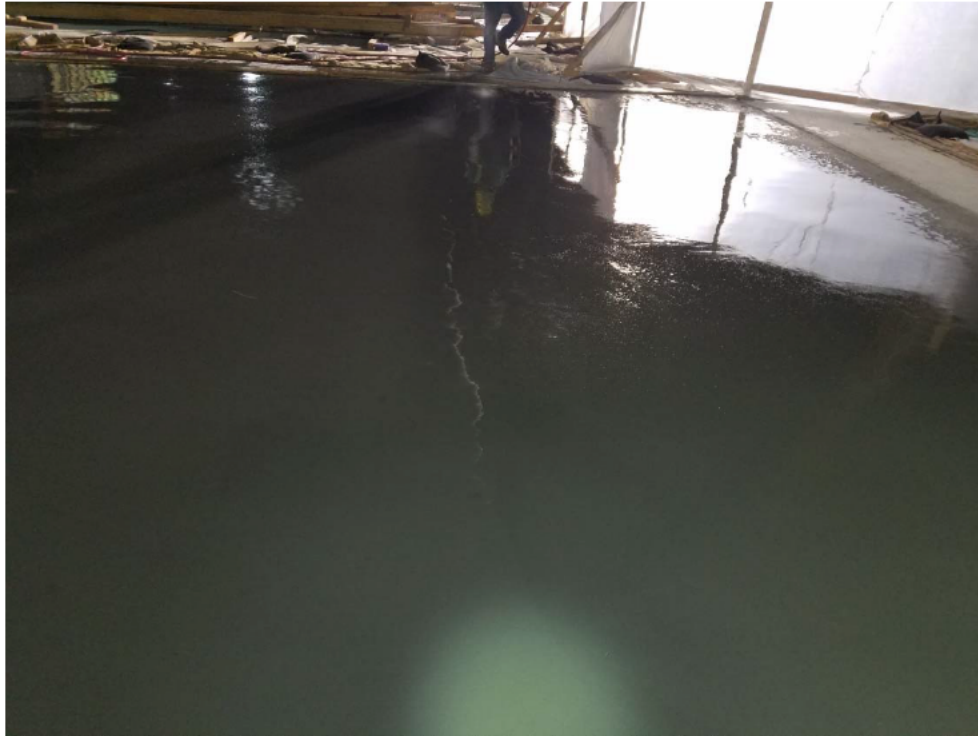
Windy placement conditions and delayed application of cure blankets may result in an increased evaporation on the finish surface, see Figure 5. In addition, poor water cure management for the duration of the required 14 days subjects the panels to potential drying and wetting cycles. Several instances occurred where the contractor did not immediately install water cure on the panel following the finishing efforts, as well as instances where the water cure was terminated or disrupted by other onsite operations introducing the variability in moisture cure. ACI 224.1R notes that “plastic shrinkage cracks begin as shallow cracks, but can become full-depth cracks later in the life of the concrete.” The contractor has attempted to mitigate the above mentioned moisture loss issues during placement and finishing efforts by using wind barriers and fogging, as well as securing the wet cure blankets to the surrounding formwork/panels as a post placement water cure management effort.

Figure 5: Cracking observed in 30C four hours after finishing

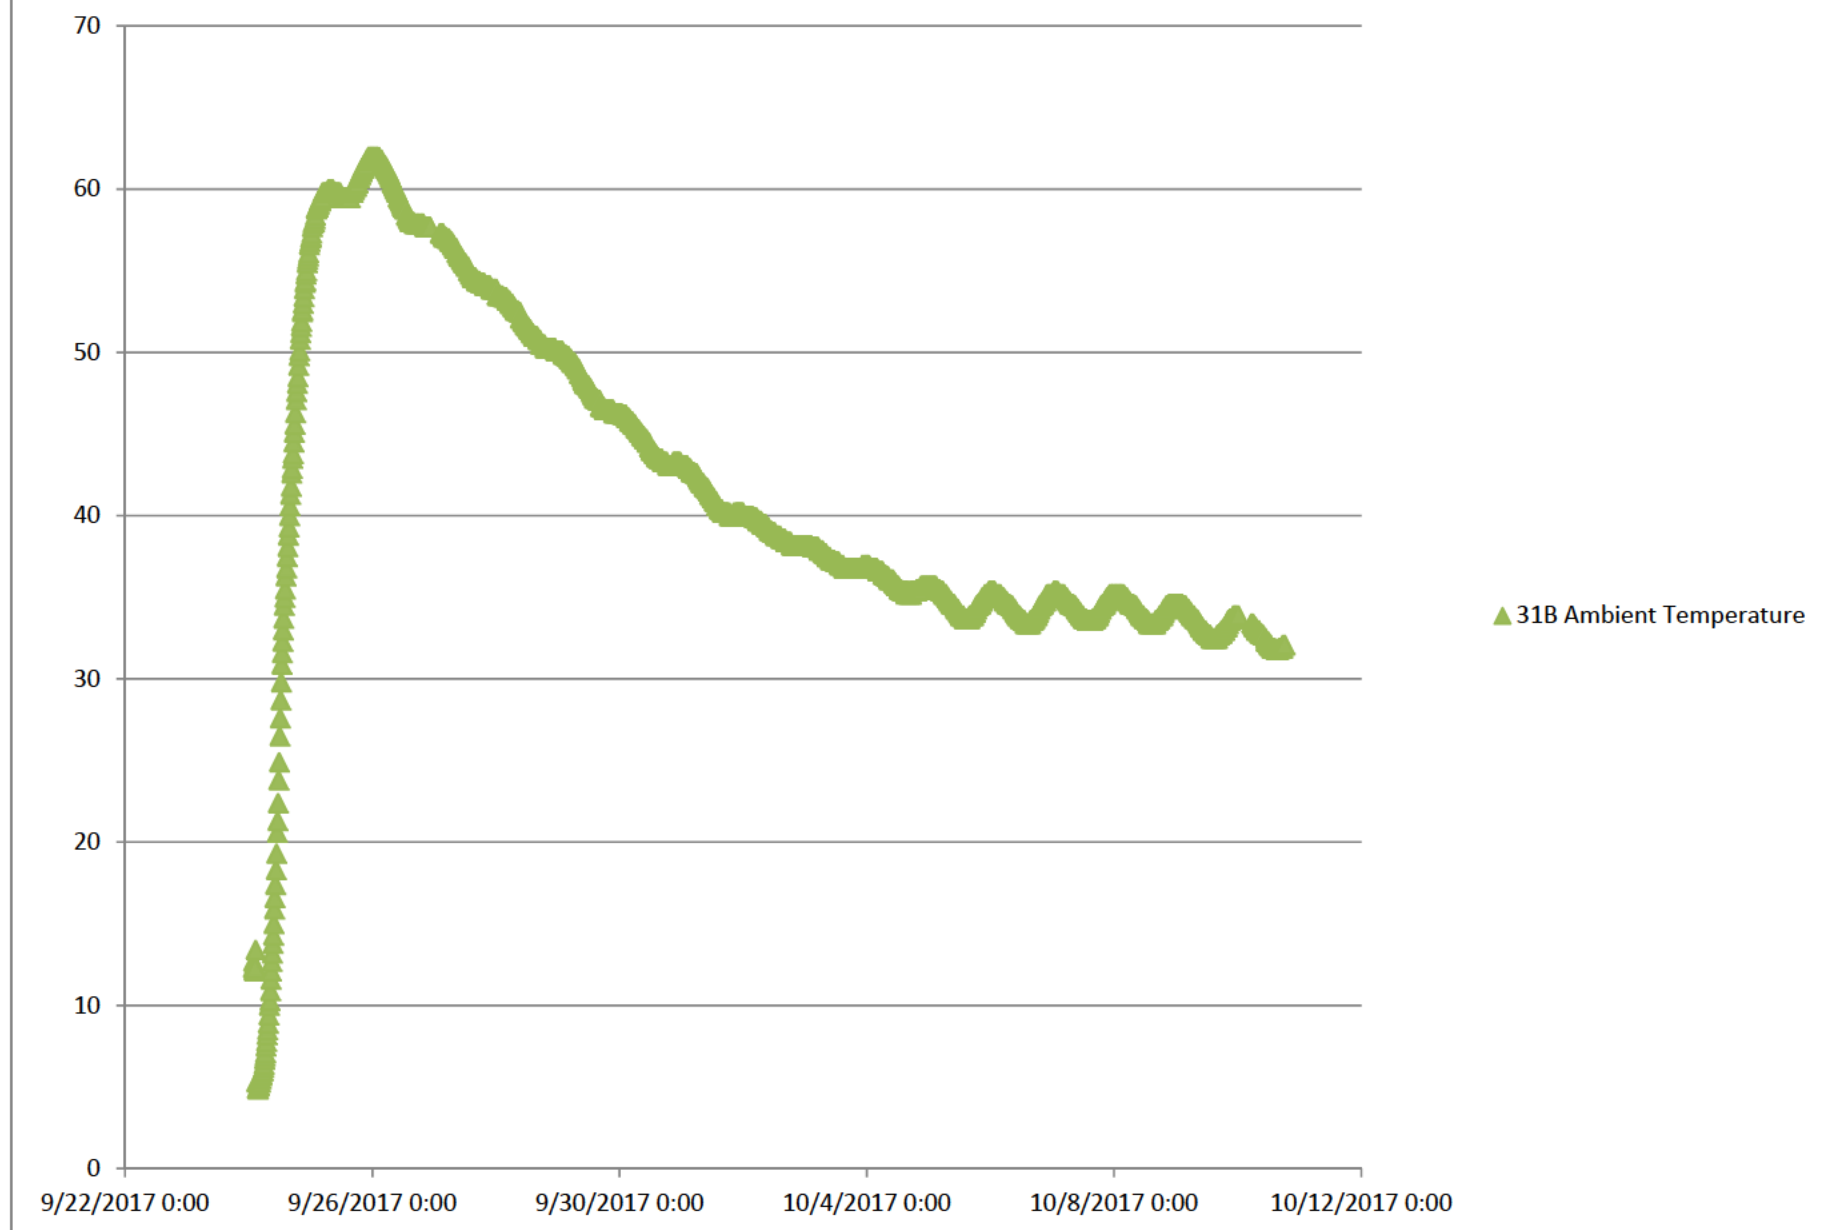
31B Heat of Hydration

Temperature gradients in a concrete structure can result in differential volumetric changes, resulting from heat of hydration and/or by the weather conditions. Currently, DWR has installed and monitored panels 31B, 44B, and 99B for temperature differentials. Panels 35D and 100D were recently installed and monitoring is underway. Attachment 2 shows both the heat of hydration change with time and the temperature increase (center of the panel) from the max placement temperature of the completed temperature monitored panels. Additionally, the instrumentation has reported the maximum thermal differential between near panel surface and internal reading of each panel as 16.4 degrees F, 18.7 degrees F, and 19 degrees F, respectively. DWR suspects that the lower temperature differential observed in panel 31B occurred because the location remained shaded for most of the day and the ambient temperatures were typically 4 and 7 degrees lower than the middle and lower chute locations, respectively. The thermal gradients never measured any greater than 35 degrees F, which suggests thermal shrinkage is not a primary cause of the observed

cracking. However, the temperature differential measured suggests that it is likely a contributor of the internal stresses, which caused cracking to occur.
